Service Bulletin Number	Date
4383753	17-DEC-2014

## Service Bulletin

### Cylinder Liner Counterbore Ledge Reuse Guidelines

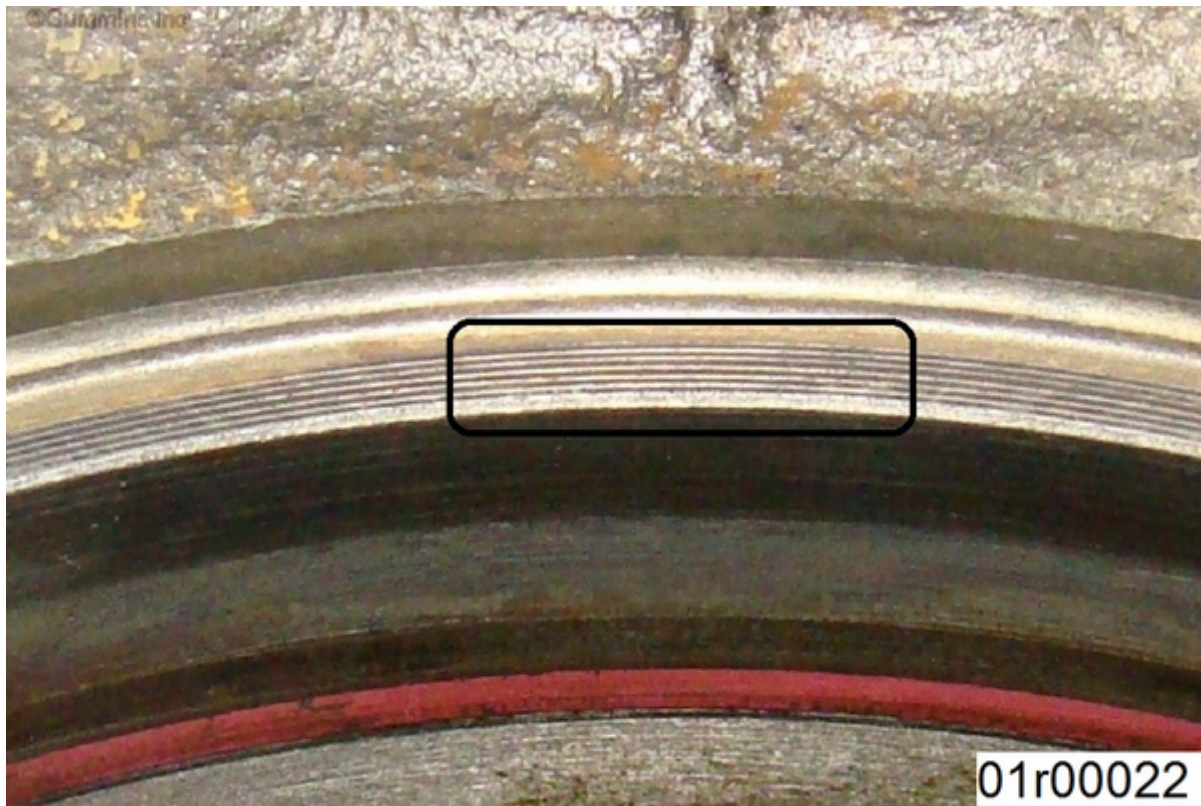
Cylinder Liner Counterbore Ledge Surface – No Surface Wear Present	
Appearance:	Grooved machining marks clearly visible. No wear present on any part of the machined surface.
Cause:	N/A
Action:	No action required – reuse.

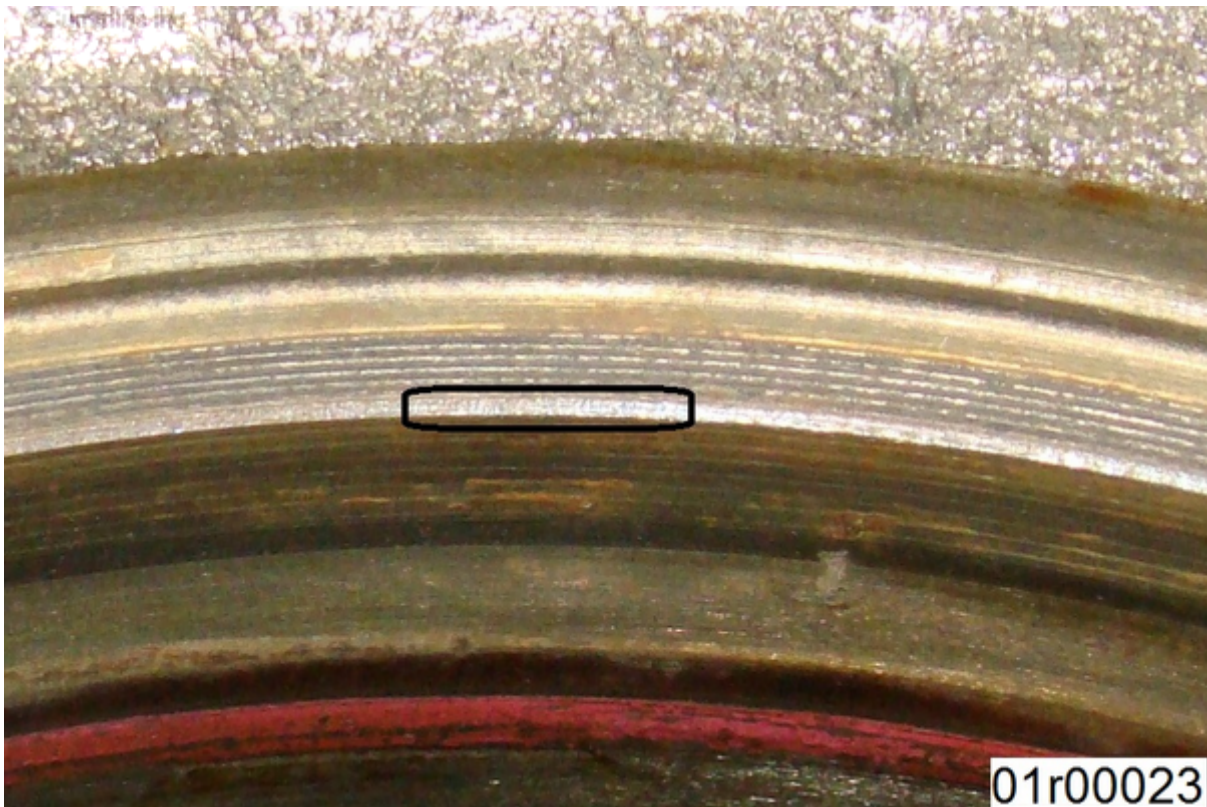
Cylinder Liner Counterbore Ledge Surface – Partial Surface Wear Present	
---	--

Appearance:	Grooved machining marks clearly visible. The counterbore ledge shows signs of partial wear along the inner diameter edge.
Cause:	Wear and/or fretting caused by cylinder liner movement.
Action:	Machine the cylinder liner counterbore ledge. Use the following procedure in the corresponding Service manual from the table above. See Procedure 001-058 in Section 1.

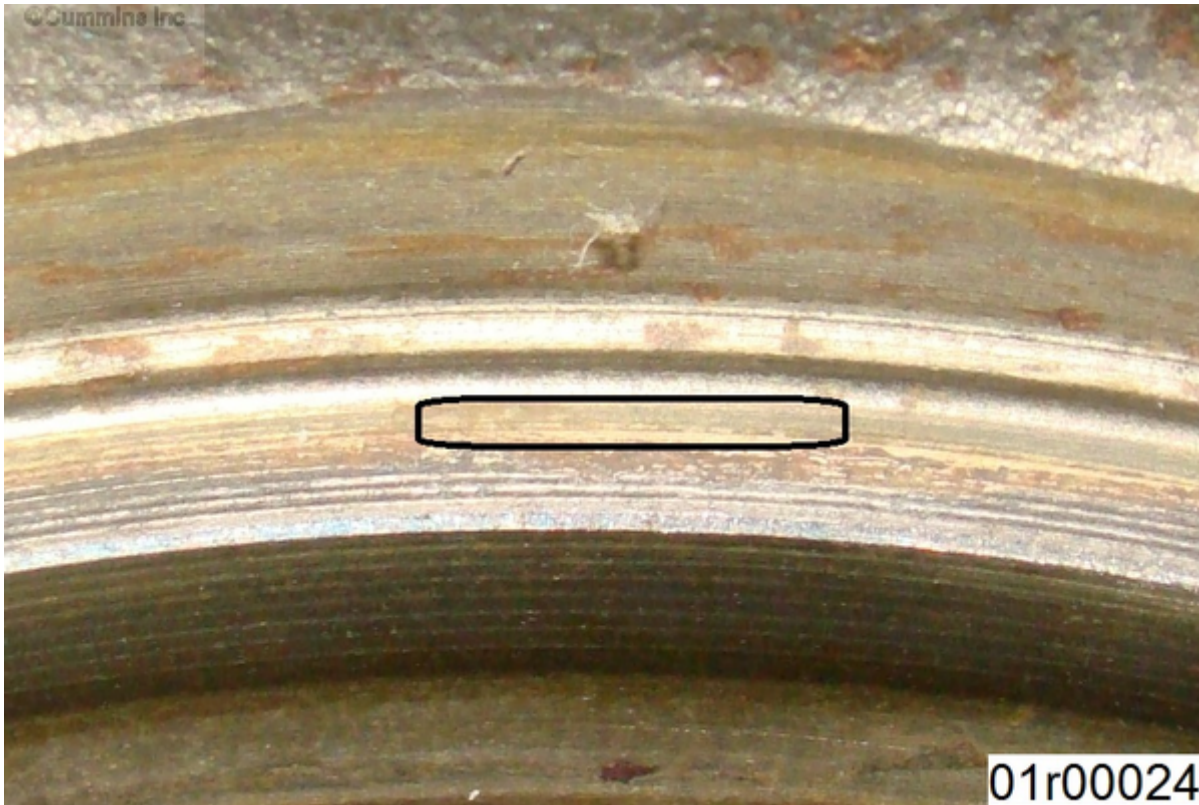
Cylinder Liner Counterbore Ledge Surface – Partial Surface Wear Present	
Appearance:	Grooved machining marks clearly visible. The counterbore ledge shows signs of partial wear along the outer diameter edge.
Cause:	Wear and/or fretting caused by cylinder liner movement.
Action:	Machine the cylinder liner counterbore ledge. Use the following procedure in the corresponding Service manual from the table above. See Procedure 001-058 in Section 1.

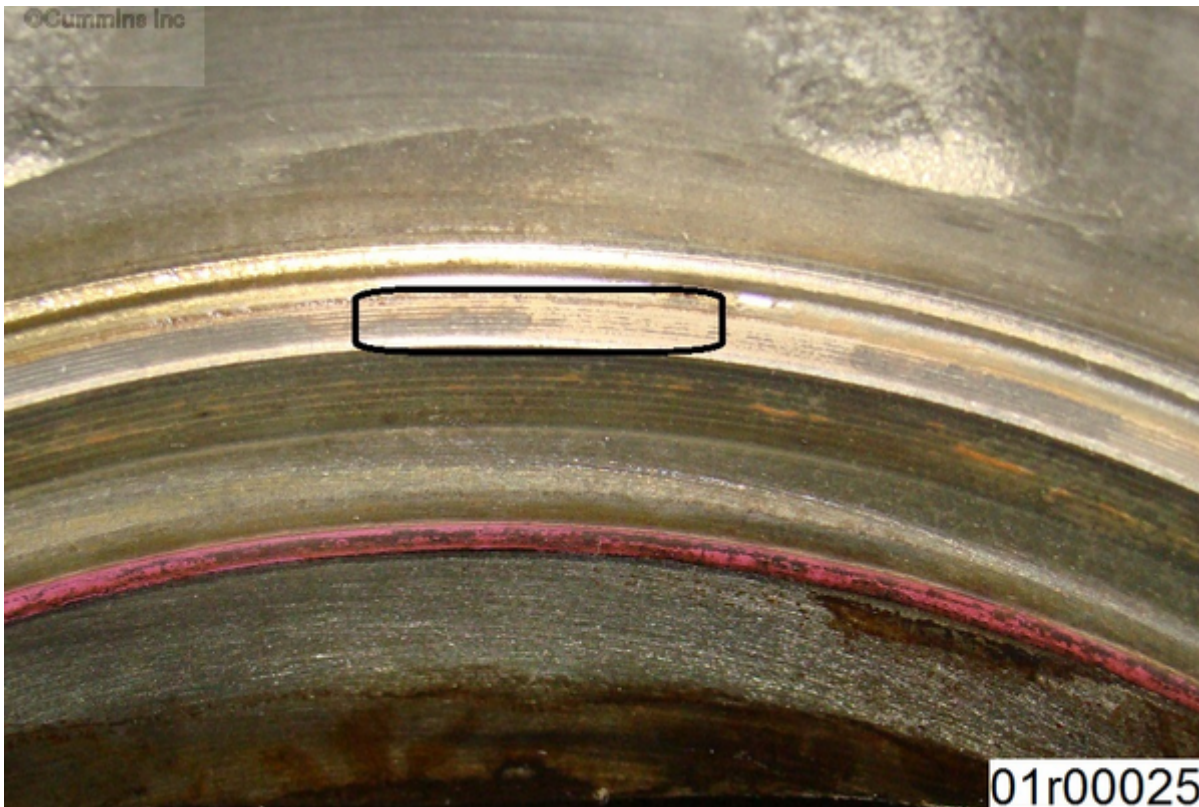
Cylinder Liner Counterbore Ledge Surface – Partial Surface Wear Present	
Appearance:	Some grooved machining marks are visible. The counterbore ledge shows signs of intermittent wear across the machined surface area. This is visible as varying depths of the grooved machining marks.
Cause:	Wear and/or fretting caused by cylinder liner movement.
Action:	Machine the cylinder liner counterbore ledge. Use the following procedure in the corresponding Service manual from the table above. See Procedure 001-058 in Section 1.

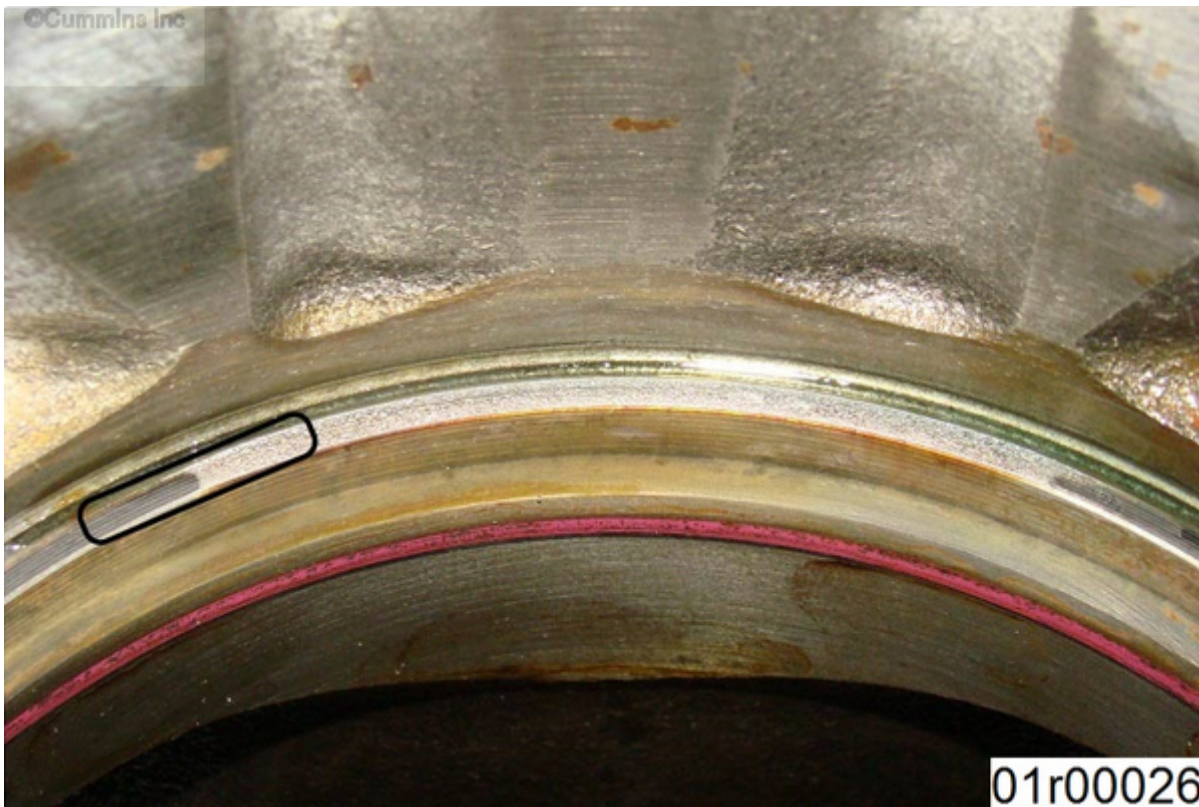
Cylinder Liner Counterbore Ledge Surface – Partial Surface Wear Present	
Appearance:	Grooved machining marks are visible in areas. The counterbore ledge shows signs of intermittent wear across areas of the machined surface. This is visible as varying depths of the grooved machining marks. The surface on the right shows signs of pitting or fretting.
Cause:	Wear and/or fretting caused by cylinder liner movement.
Action:	Machine the cylinder liner counterbore ledge. Use the following procedure in the corresponding Service manual from the table above. See Procedure 001-058 in Section 1.

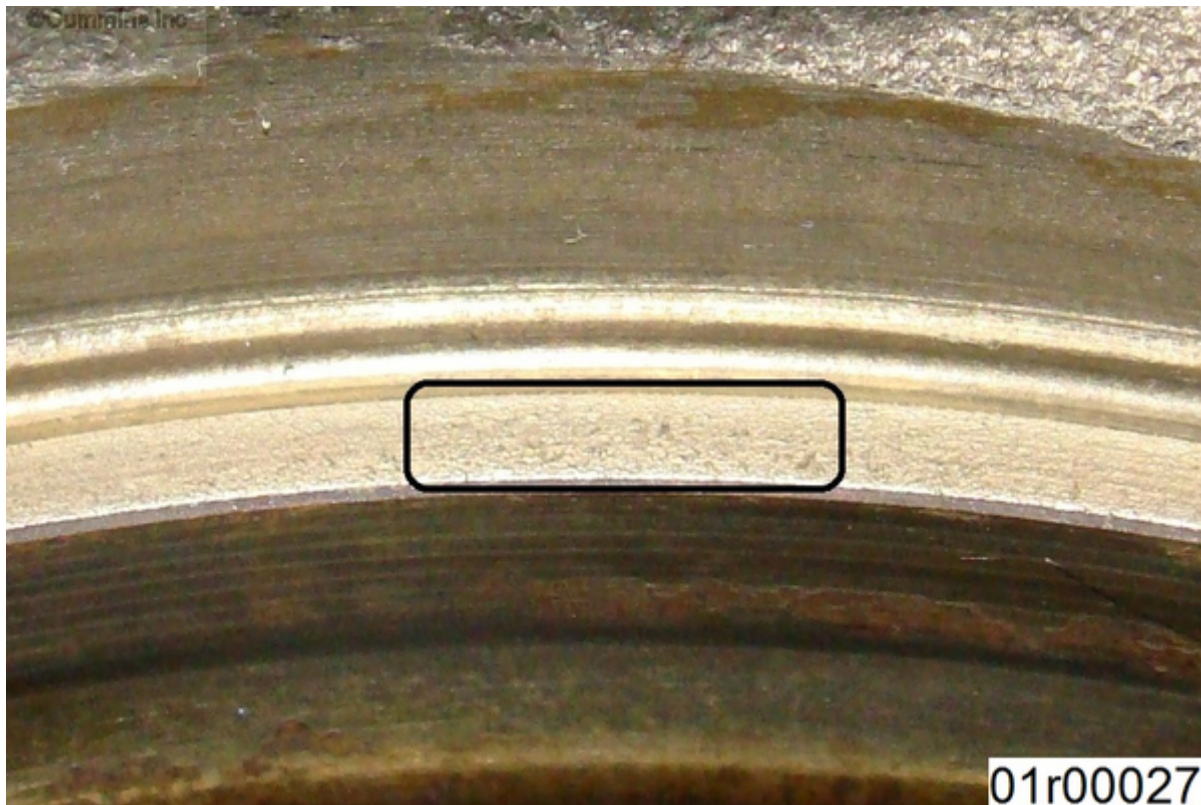
#### Cylinder Liner Counterbore Ledge Surface – Complete Surface Wear Present

Appearance:	No grooved machining marks are visible. The counterbore ledge shows signs of wear across the entire machined surface area. This is visible as removal of the all grooved machining marks from the cylinder liner counterbore ledge surface. The surface shows signs of pitting or fretting.
Cause:	Wear and/or fretting caused by cylinder liner movement.
Action:	Machine the cylinder liner counterbore ledge. Use the following procedure in the corresponding Service manual from the table above. See Procedure 001-058 in Section 1.
