E254

43 - Exhaust

Broken Aftertreatment Diesel Oxidation Catalyst (DOC) Baffle may occur in vehicles built with EPA 2017 PACCAR MX13 or MX-11 engines with right hand under cab (RHUC) exhaust configurations.

Technical Information Bulletin

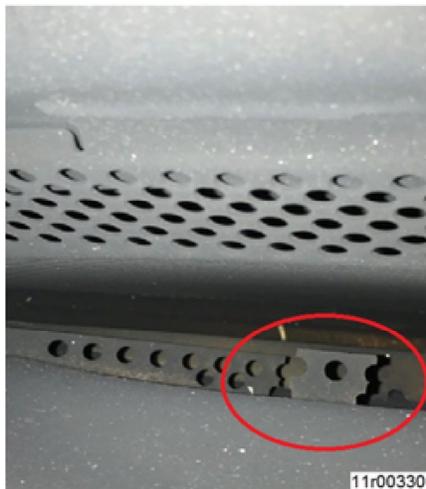
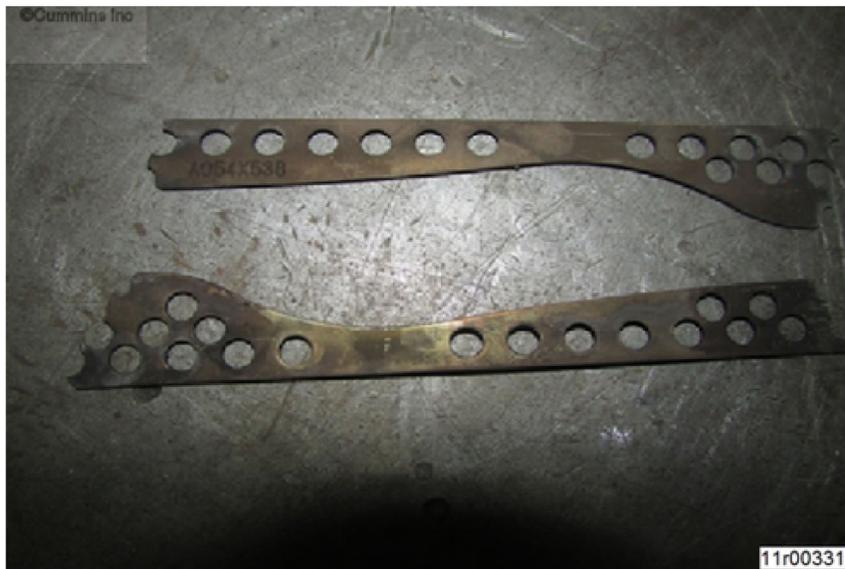
Troubleshoot the fault code and inspect the inlet of the aftertreatment DOC for a broken baffle.

If a broken baffle is found in the DOC, replace the DOC.

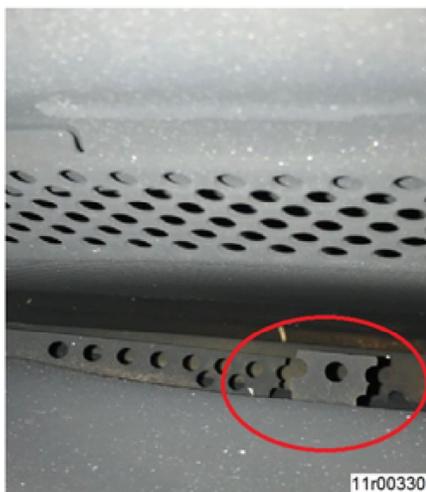
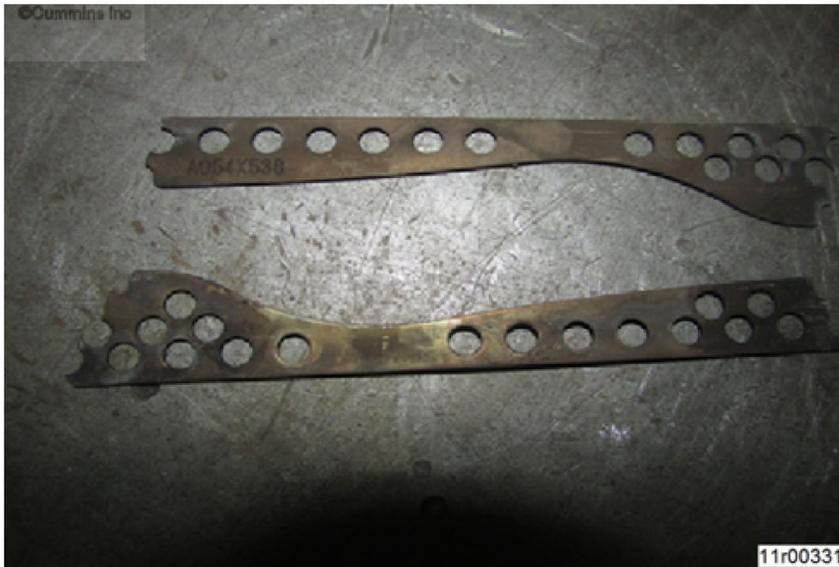
Troubleshoot the fault code and inspect the inlet of the aftertreatment DOC for a broken baffle.

If a broken baffle is found in the DOC, replace the DOC.
